#### **Chronology and Photo Descriptions**

The WPCF Permit was issued by DEQ on January 31<sup>st</sup>, 2018, as a result of the September 18<sup>th</sup>, 2017 submission of the Application. A number of delays during and before the construction occurred, caused primarily by two factors....weather constraints, and contractor scheduling difficulties. Excavation for the first filter was begun in early June, 2018. The entire project, including grass cover seeding, was completed by the 1<sup>st</sup> of March, 2019. Jack Akin of EMC-Engineers/Scientists, LLC (EMC), Engineer-of-Record for this project, took some photos during frequent visits and on-site communications with the septic system contractor (Roury Summers of RotoRooter). The photos below are briefly described.

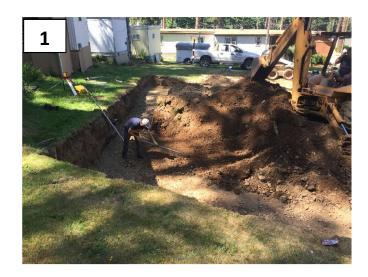
Photo 1, taken on June 4<sup>th</sup>, 2018, shows the initial excavation of Filter 1, the northmost filter in the system. During the excavation old septic system pipes were encountered and removed, as seen in **Photo** 2, taken on June 7<sup>th</sup>, 2018. **Photo 3**, taking on June 21<sup>st</sup>, shows the initial filter sidewall construction and some of the drain rock placed inside the construction in Filter 1. Another side view of the side wall is shown in **Photo 4**, and the gravel and soils support is shown in the June 29<sup>th</sup>, **Photo 5**. The **6<sup>th</sup> photo**, taken June 21st, shows some construction being done on Filter 2. The mid-layers of gravel placed in Filters 1 and 2 are shown completed in this Photo 7, taken on July 25th. Photo 8, taken On August 10th, shows the placement of pipe from the pump vault near the septic system to the filters. Photo 9 shows the distribution system. A 2-way distribution distributor valve is used to alternate between the two filter systems. The North Filter system is comprised of Filters 1 and 2. The South Filter system is comprised of Filters 3 and 4. Each of these filter systems utilize 5-way distributor valves downstream and in series from the 2-way distributor valves. EMC measured distributor pipe hole diameters, as seen in **Photo 10**, Taken on August 27, 2018. The zonal pipe distribution system, typical of all 4 filters of this system, is shown in **Photo 11**, taken On August 27<sup>th</sup>. On the same day, Photos 12 and 13 were also taken. **Photo 12** shows the pipes going through the side walls via grommet connections, and an extension of those pipes, one from each zone, is seen in **Photo 13**. **Photo 14**, taken on August 31<sup>st</sup>, shows the pressure test taken at Filters 1 and 2. All zones were tested, reviewed by EMC. As can be seen in the photo, pressure energy exceeded the necessary 5 feet of head. Photo 15, taken on August 31st, shows a worker placing the covers atop the distribution pipe holes. **Photo 16**, taken on September 7<sup>th</sup>, shows a worker with a level measuring the elevation of gravel being placed over distribution pipes. Photo 17 shows the fabric being placed on September 19<sup>th</sup>. **Photo 18** was taken On October 24<sup>th</sup>, and shows the placement of the first layer of gravel over the base layer of 1 ½" inch diameter drain rock at Filter 3. Photo 19 shows the main pipes running from the North Filters to the South Filters, and that photo was taken on December 5<sup>th</sup>. On the same day Photos 20 and 21 were taken. Photo 20 shows the pipe system 2-way distributor valves, which alternate between the systems, and **Photo 21** shows the pressure test for the upper filter system. It can be seen in this photo that pressure energy was well over the required 5 foot head. Photos 22 and 23 show exterior and interior views of the system control panel.
