MEMO-122217-01

To: Gary Dehlinger
Manager, Port of Brookings
cc: Bill Kerschke, Environmental Specialist
FEMA Region X
130 228th Street SW, Bothell, WA 98021
From: Jack Akin
EMC-Engineers/Scientists, LLC
RE: Completion of Pile & Dock Repair, Port of Brookings

On Thursday, June 20th, 2019, Jack Akin of EMC-Engineers/Scientists, LLC (EMC), at the request of Gary Dehlinger, Port of Brookings Manager, completed the final inspection of the installations and repair via the FEMA-approved project entitled ST-307 Pilings and Boarding Ramps, Declaration No. 4258, PA ID 015 UIZ5Q. The project was authorized under the October 26, 2018, USACE Permit No. NWP-1999-381/6.

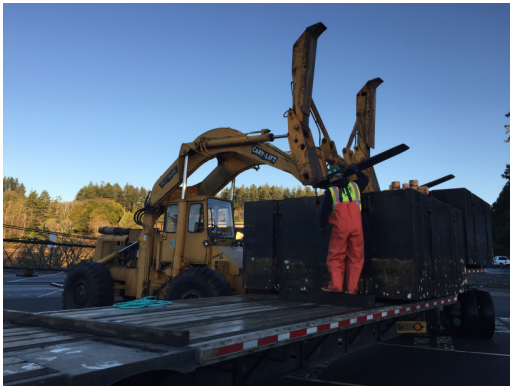
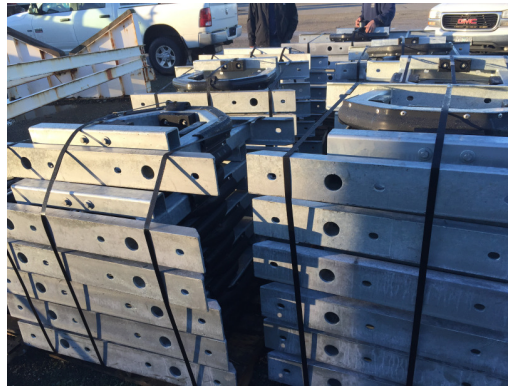
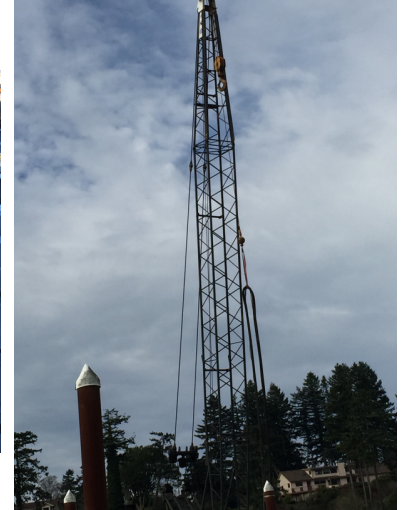
Trucks delivering pipe and harnesses (hoops) arrived in January, staged and off-loaded at the Port north parking lot as shown. Third photo from the left shows the derrick used to remove old piles, and place and drive new piles.

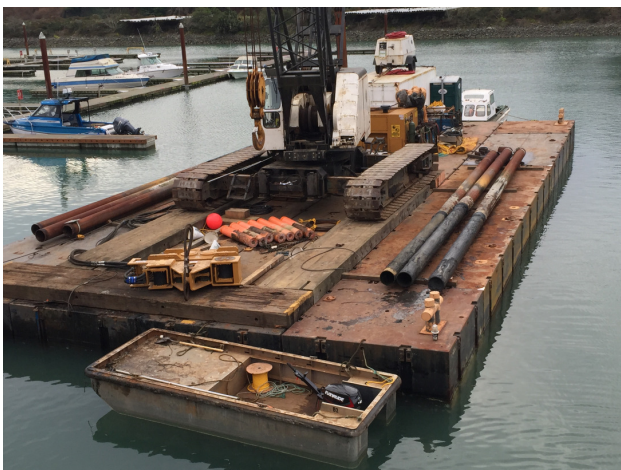
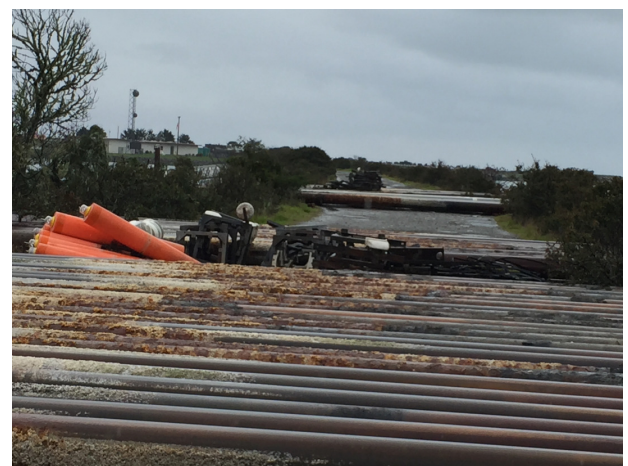
Old piles, as removed, were staged on the 30' X 60' modular barge, to be off-loaded by the derrick onto the temporary storage location on the jetty separating the Chetco River from the Port of Brookings Sport Basin.

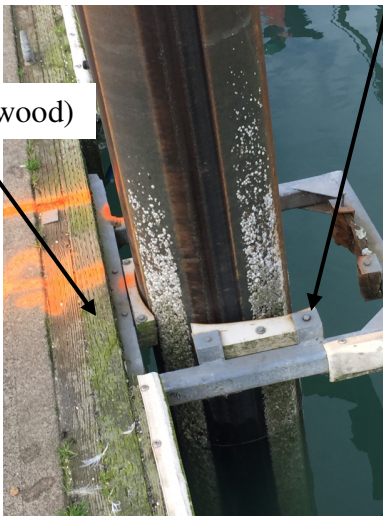
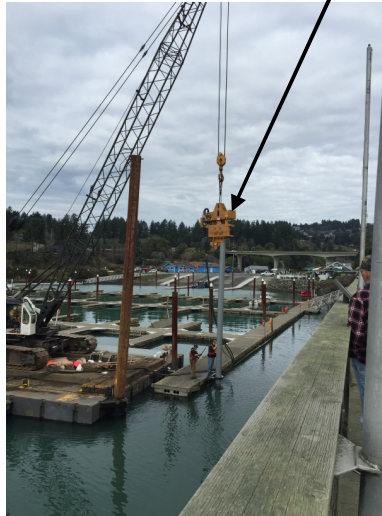
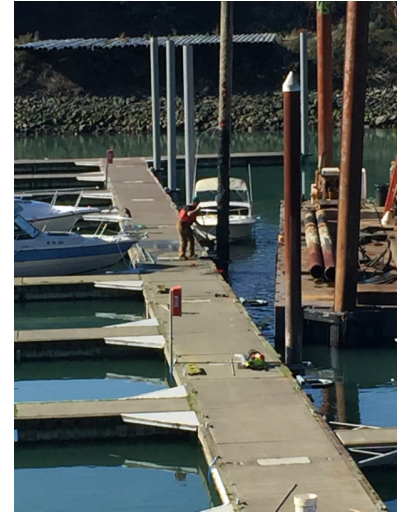
Old pile systems (30' – 45', uncoated steel piles, worn hoops and split and splintering dock walers were removed, and new piles placed via derrick and vibrating hammer (see center photo). As old piles were removed, docks were held stationary and walers marked. As seen new piles are gray-coated.

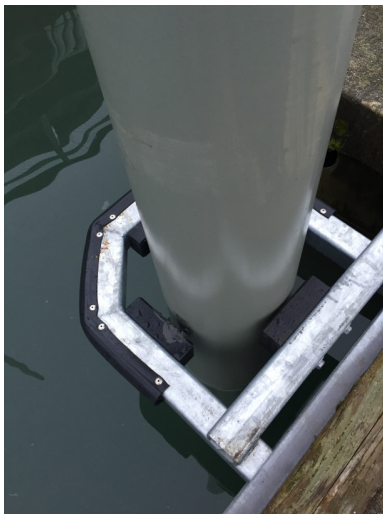
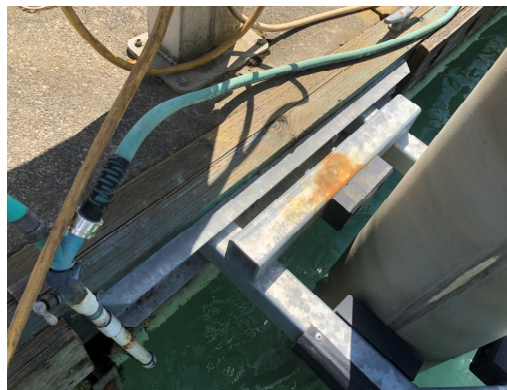
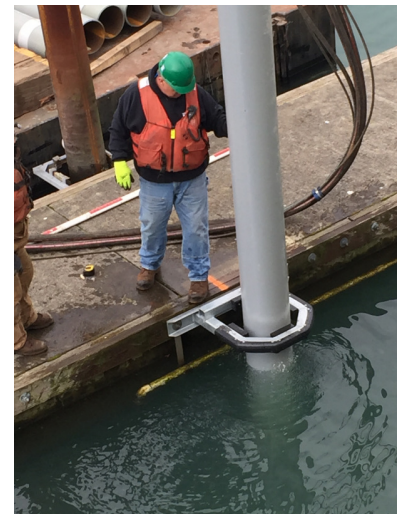
Hoops were installed through dock walers as shown. Thence piles were aligned and driven via vibratory hammer. Vibration patterns were mild, as seen in the RHS photo above.

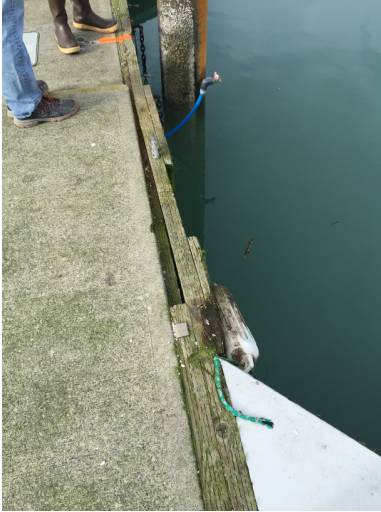
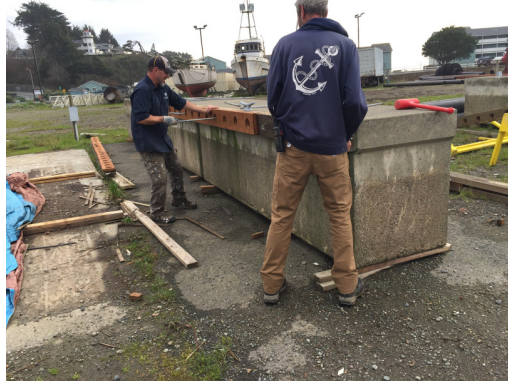
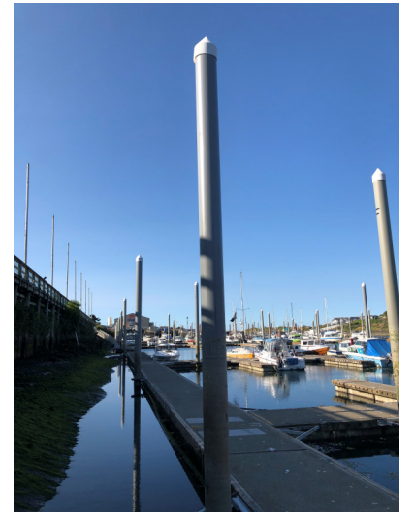
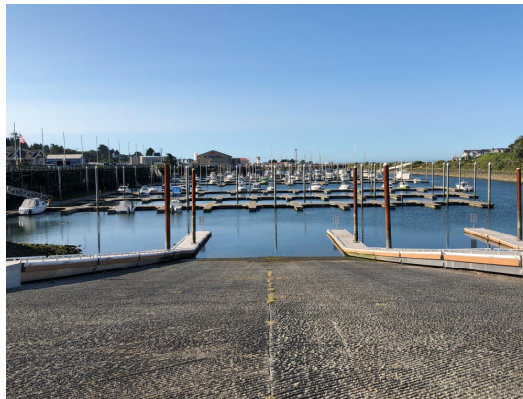
Walers were mostly repaired in place but in some cases were removed and repaired at Port of Brookings Harbor boatyard. Piles in-place and coned were measured by the engineer-of-record, and noted to be well aligned vertically, and at even height about 21 feet above tops of hoops. Photo lower-center (looking southward from the launch ramp approach, on 6/20/19) shows the Sport Basin, with all new piles and boarding ramp docks in place.
