EXHIBIT B – Septic Tank Installation

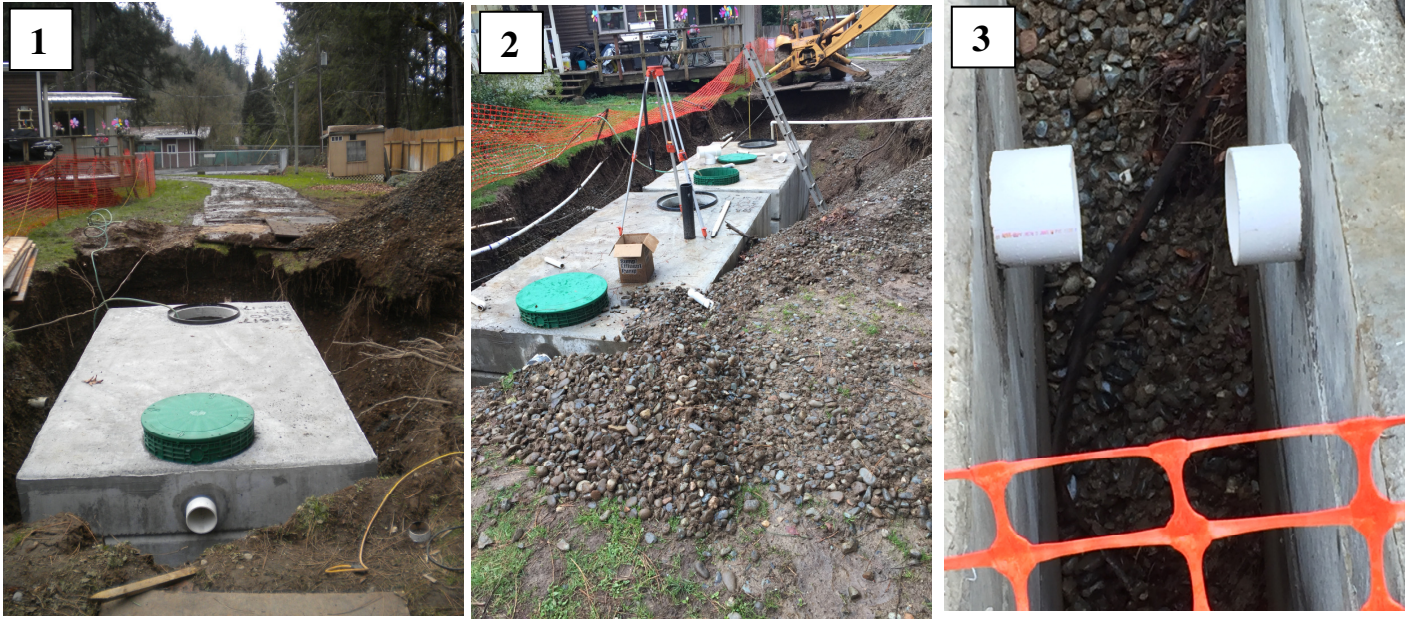
Photo 1 shows the single 3000 (approx. 3095 capacity) concrete septic tank, placed and leveled. Photo 2 shows the Site after the second tank is placed. Photo 3 shows the alignment (effluent of eastward effluent into influent of west-adjacent septic tank). These two will accumulate most solids over time.

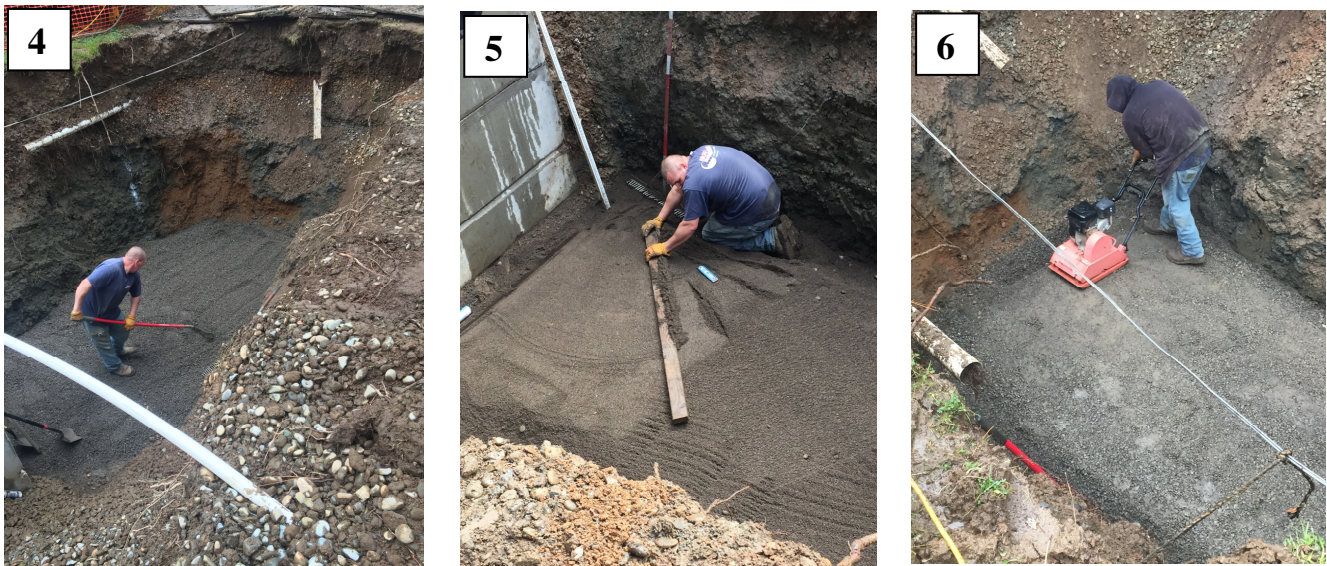
The hole is then extended westward to allow for the installation of the third septic tank. Photo 4, 5 and 6 show the raking, leveling and compacting of the tank floor to the elevation necessary to continue fluid flow from the second tank influent (+79" to invert).

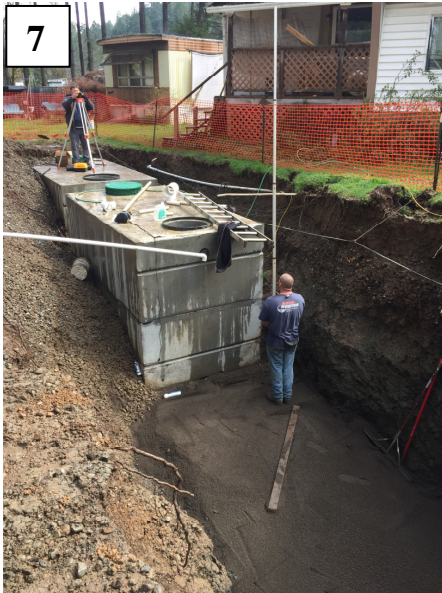
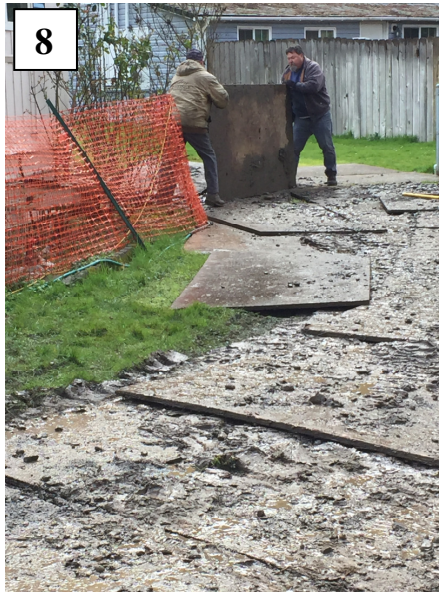
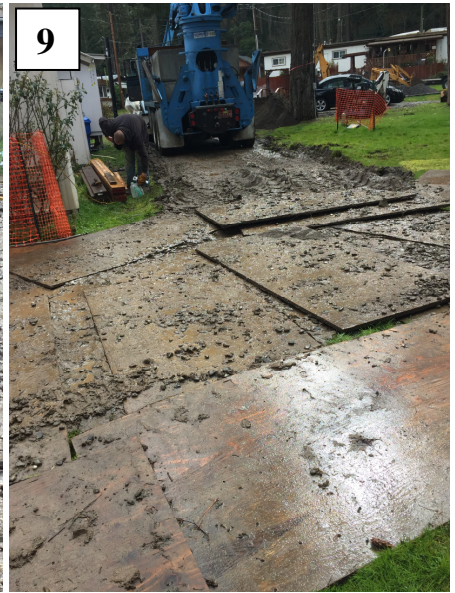
Final elevation checks before placement of the third tank are performed, as shown in Photo 7. Then placement and shifting of 1" plywood boards must be done to provide adequate traction for truck and boom, as seen in Photos 8 and 9.

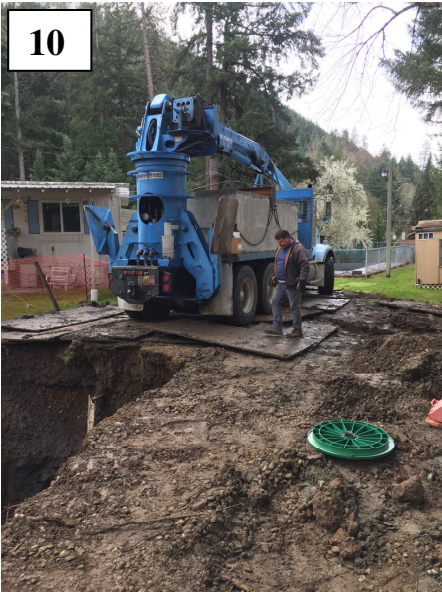
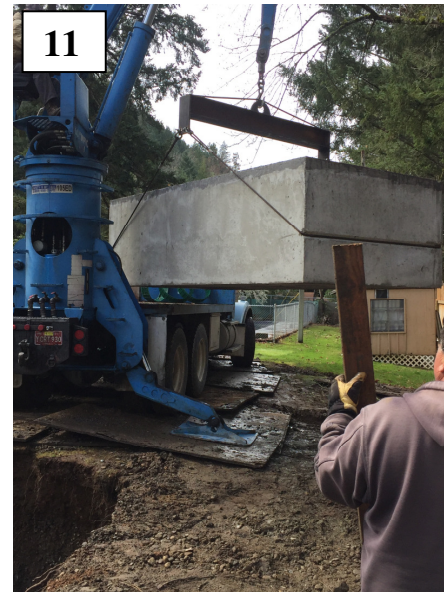
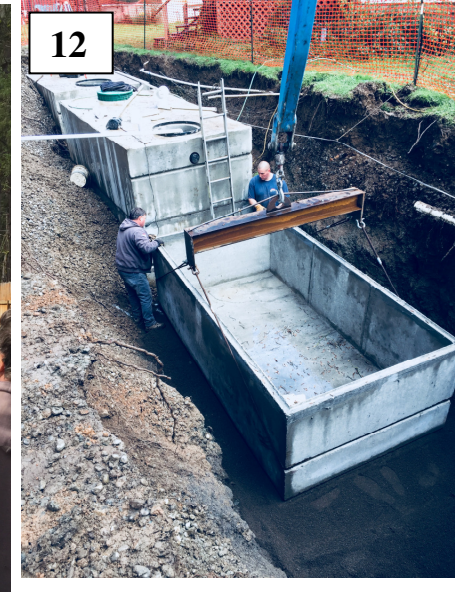
As shown in Photos 10, 11 and 12, the bottom half of the third tank is placed in position and aligned according to field measuring and painted markers.

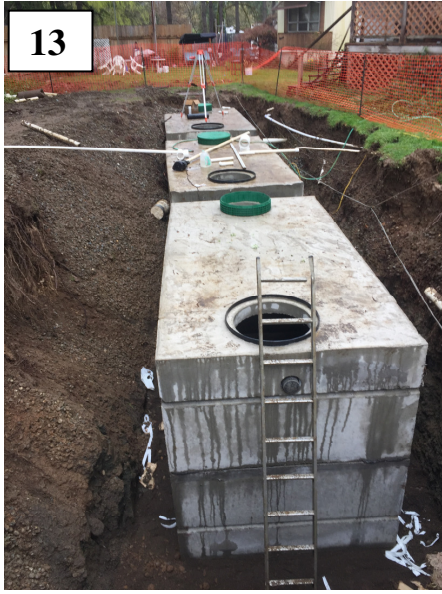
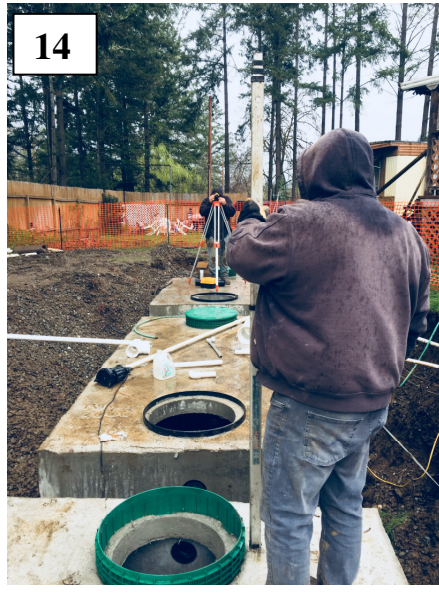
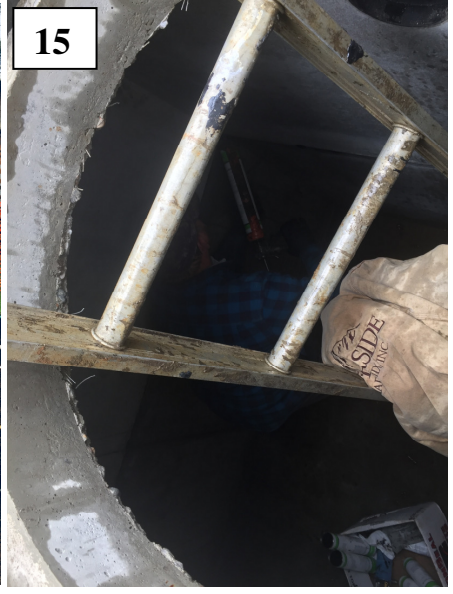
Similarly, the top half of the septic tank is placed, correct elevation of the third tank assured, and interior sealing between top and bottom tank halves is completed (Photo 15). After each of these tank installations, before excavation for the next tank, each tank is filled with water to above the tank seam to assure tank tightness.
