Port of Bandon

Boat Basin and Launch Ramp Areas Submerged Aquatic Vegetation Mitigation Project

7/26/15

Jack Akin, MS, PE

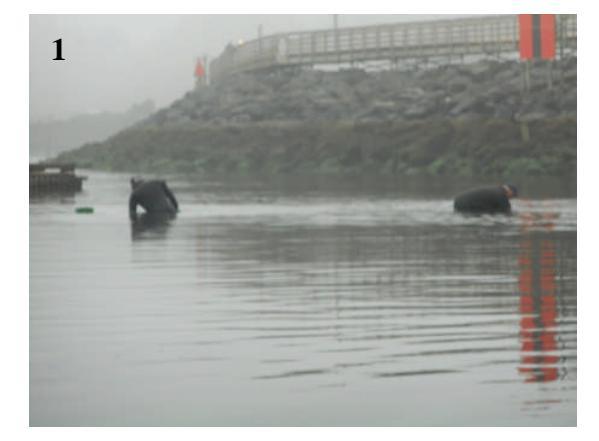
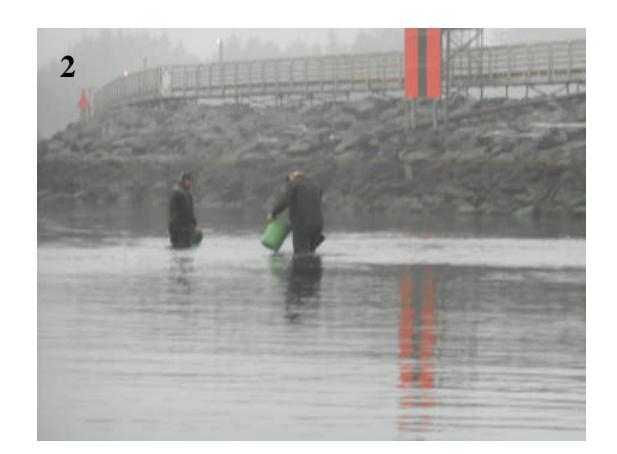
Beginning 5:45 A Saturday, August 1st, one team of three began harvesting donor site areas and continued until all were removed (see Exhibit C and Key).

The plants were harvested by hand and small spade by pressing the spade 6 to 8 inches into the soft sediment approximately 4 inches away from the plant, and then pressing fingers beneath the plant rhizomes. Thus it was found that the effective removal with minimal damage could be accomplished. Each plant was removed in this way until all of the areas to be mitigated were cleared.

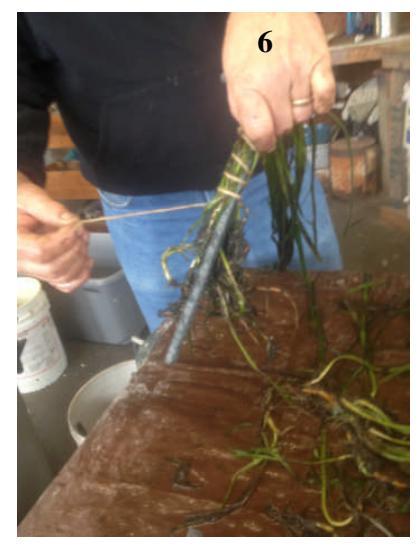
Eelgrass bunches were staged as shown in Photo 5, and then bound to the "T" welded rebar as seen in Photo 6.

Iron bar "Ts" were welded as shown in Photo 6, and plants, each having rhizomes of 2 inches or greater (see Photo 4) in length were bound to the bar legs with a length of jute string. Plants were attached to rebar in bunches ranging from 4-15 plants. A total of about 1800 plants were prepared in this way.

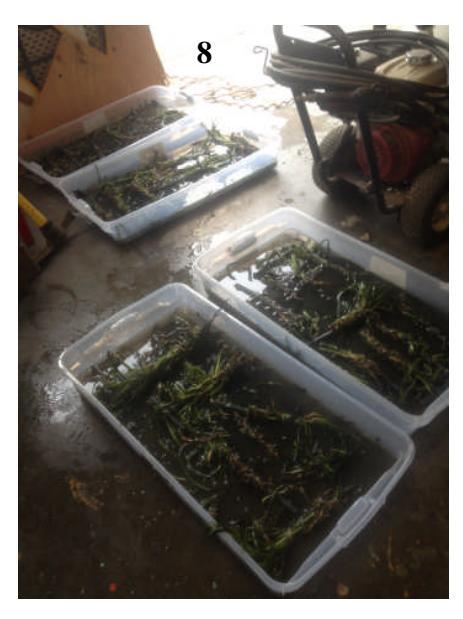
The loaded totes shown in Photo 8 were covered and secured until the planting event during the next lowest minus tide the following morning (August 2nd, 2015).

After the rebar plugs were so constructed, they were placed in plastic totes (see Photos 7 & 8), and then sea water was poured into each one of the totes until all plants where completely submerged. The totes were staged in the Port of Bandon maintenance shop for planting the following morning.

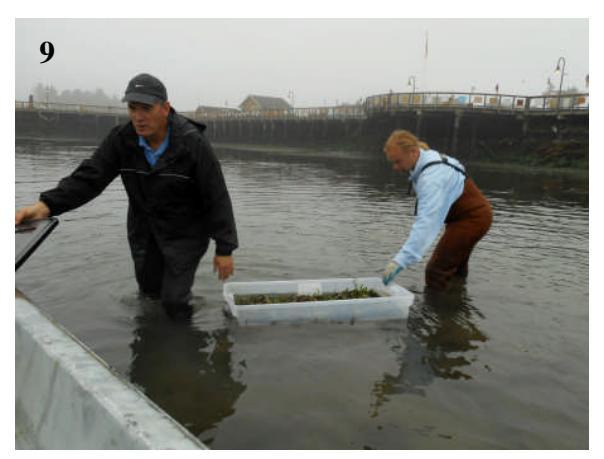
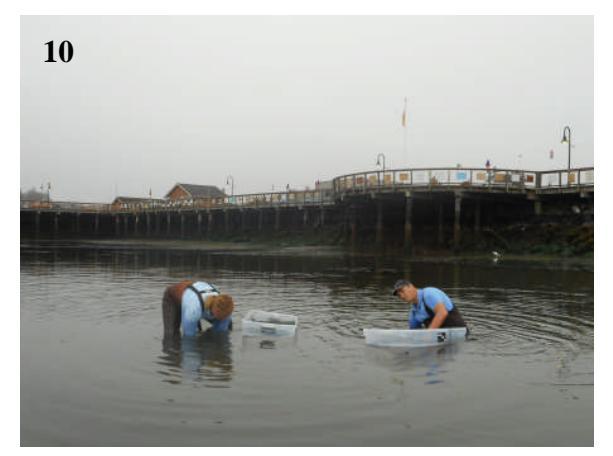
Planters worked side by side with the inside planter leading, planting one row each, keeping 3' away from each other, from west to east on the first leg to plant the 1^{st} and 2^{nd} rows, and then back from east to west to plant the 3^{rd} and 4^{th} rows.

On August 2nd, 2015, at about 6:20 A (approaching lowest tide), the replant phase of the project began (see Photos 9 & 10). Each plug was planted by placing the pointer and index finger over the rhizome while grasping the plug and pressing it into the soft sediment. The top of the rebar "T" was then pressed to about 2" below mudline.

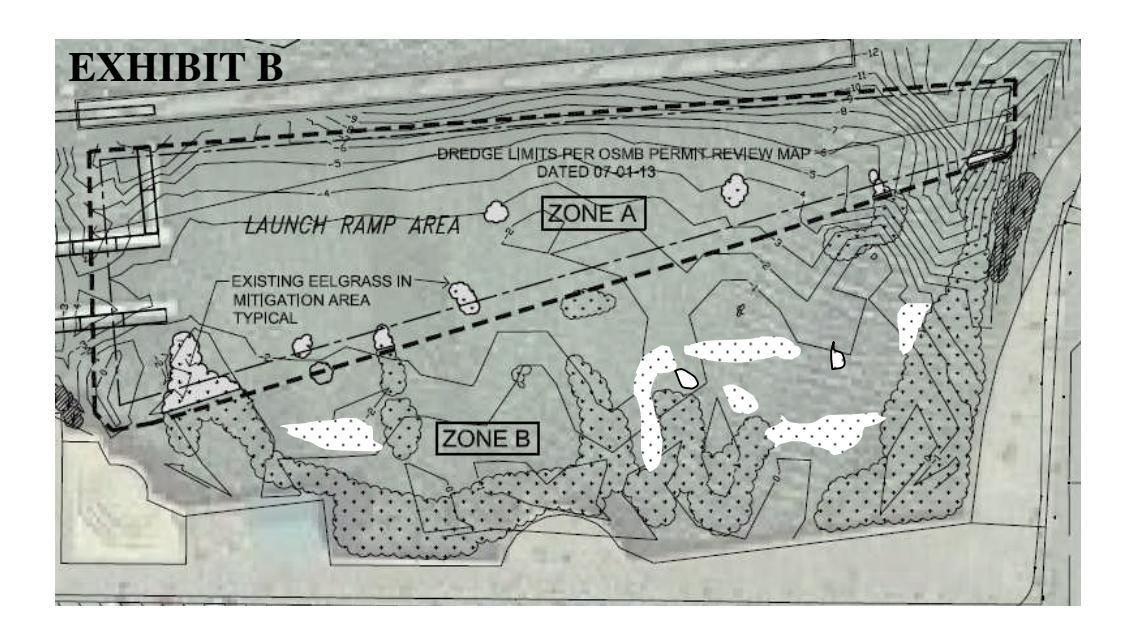
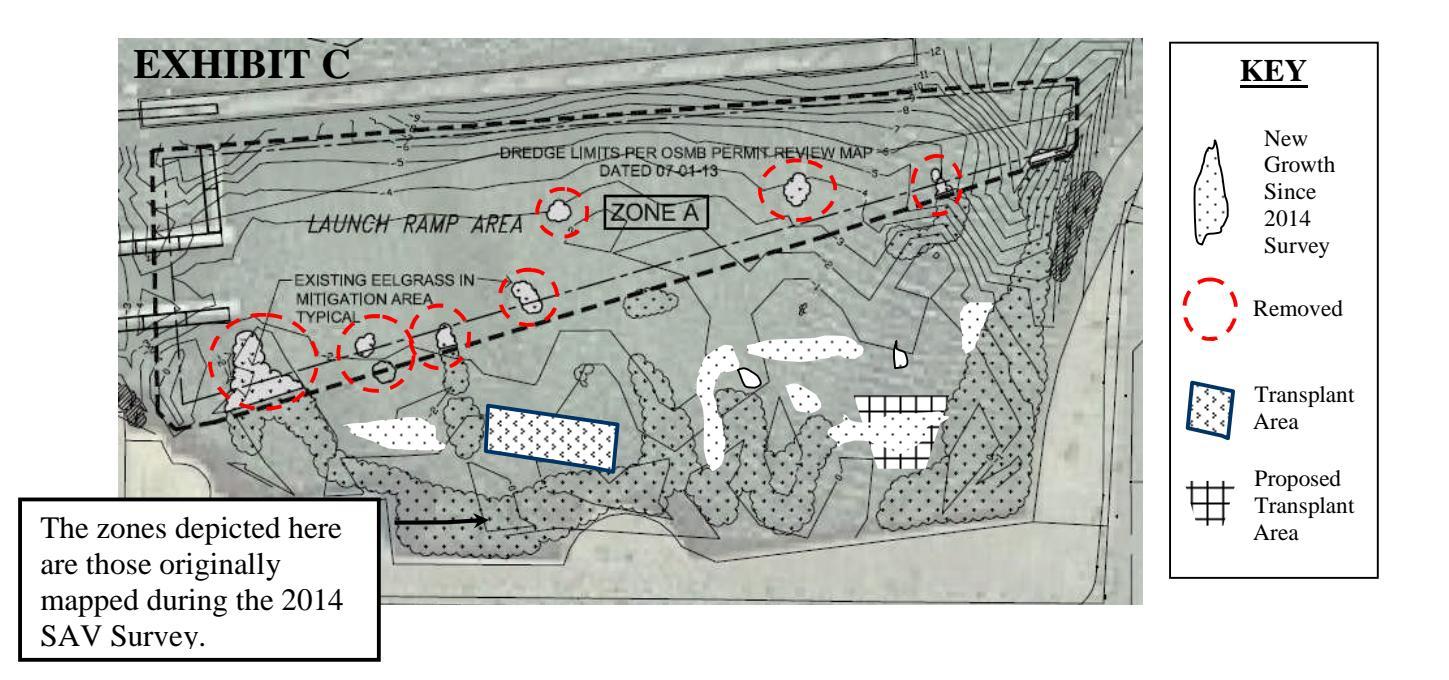
The plugs were spaced approximately 4' X 3' in the transplant site (see Exhibit C, producing an approximately 105' X 12' replant area, w/ 3' offset from existing eelgrass patches), in order to fill the adjusted designated transplant area and match the donor site plant density. This harvesting and transplanting event took place during very low tides, and took a total of three days to complete.

Significant growth had occurred since the 2014 SAV Survey, approximately indicated in Exhibit C. The area proposed to be the Transplant Site in the 7/10/2015 Mitigation Plan has since experienced growth of eelgrass patches at least to "low" densities. Therefore, during the 6/29 - 7/02/15 Transplant Project, with tides unusually low, the new Transplant area was selected, as shown in Exhibit C and Key.

The location shown in "snapshot' placed on Page 9 of the Mitigation Plan was found to have largely been populated with recent eelgrass growth. Therefore a nearby location in the same area was selected, as shown in the drawing entitled "Exhibit C", on Page * of this report.
