Port of Bandon Boat Basin and Launch Ramp Areas

Submerged Aquatic Vegetation Mitigation Plan

12/30/14

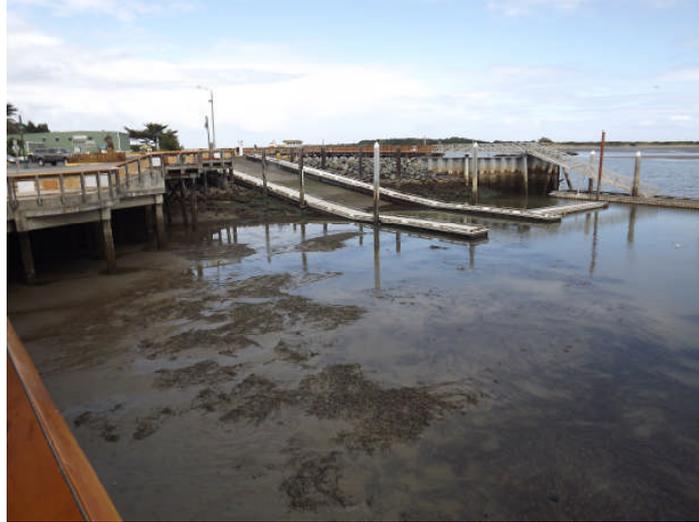
Looking westward at the Launch Ramp area from a shoreline midpoint, extents of eelgrass beds are clearly visible.
